Subject: FW: Gold King Mine Spill - brief background and initial EPA Region 9 response (internal - do

# When our river turned orange

Nine things you need to know about the Animas River mine waste spill.

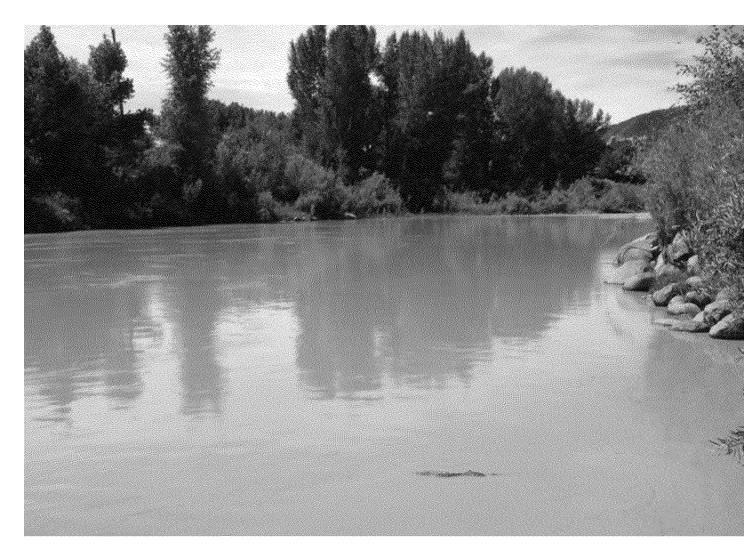
The river turned a mustardy-Tang color as the wastewater moved through. This was taken about 24 hours after the spill.

The mustard-Tang plume was the result of approximately three million gallons of wastewater and sludge that had poured from the dormant Gold King mine into Cement Creek, a tributary of the Animas, some 50 miles upstream on the previous morning. The water had backed up in the mine behind a sort of dam formed when the mine portal's ceiling had collapsed sometime earlier. Workers from the Environmental Protection Agency were hoping to install a pipe to drain the water so that they could eventually plug the mine, keeping the contaminated water inside it and out of the streams. Instead, they ended up accidentally breaching the dam, releasing the water.

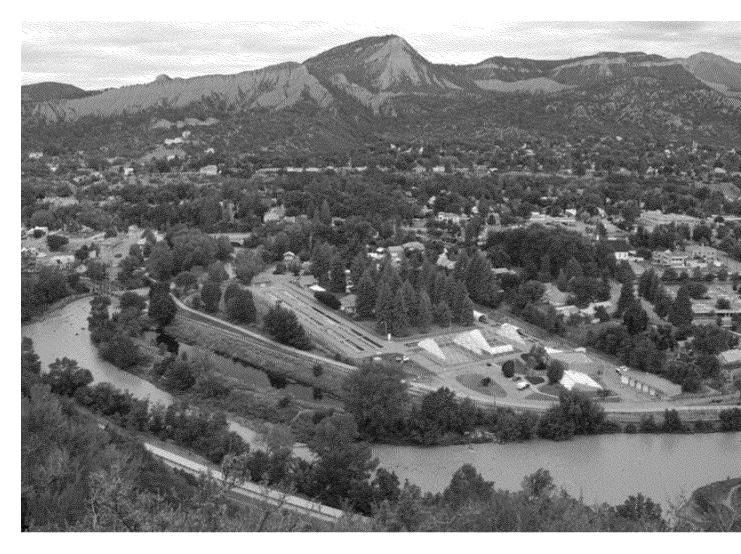
The contaminated Animas River as it runs through Durango. Note the contrast between the river and a fish hatchery pond next to it.
